**Grey Eagle Mine Mitigation Review Site Visit**  
**Clayton Creager – Site visit photographs - August 9, 2011**

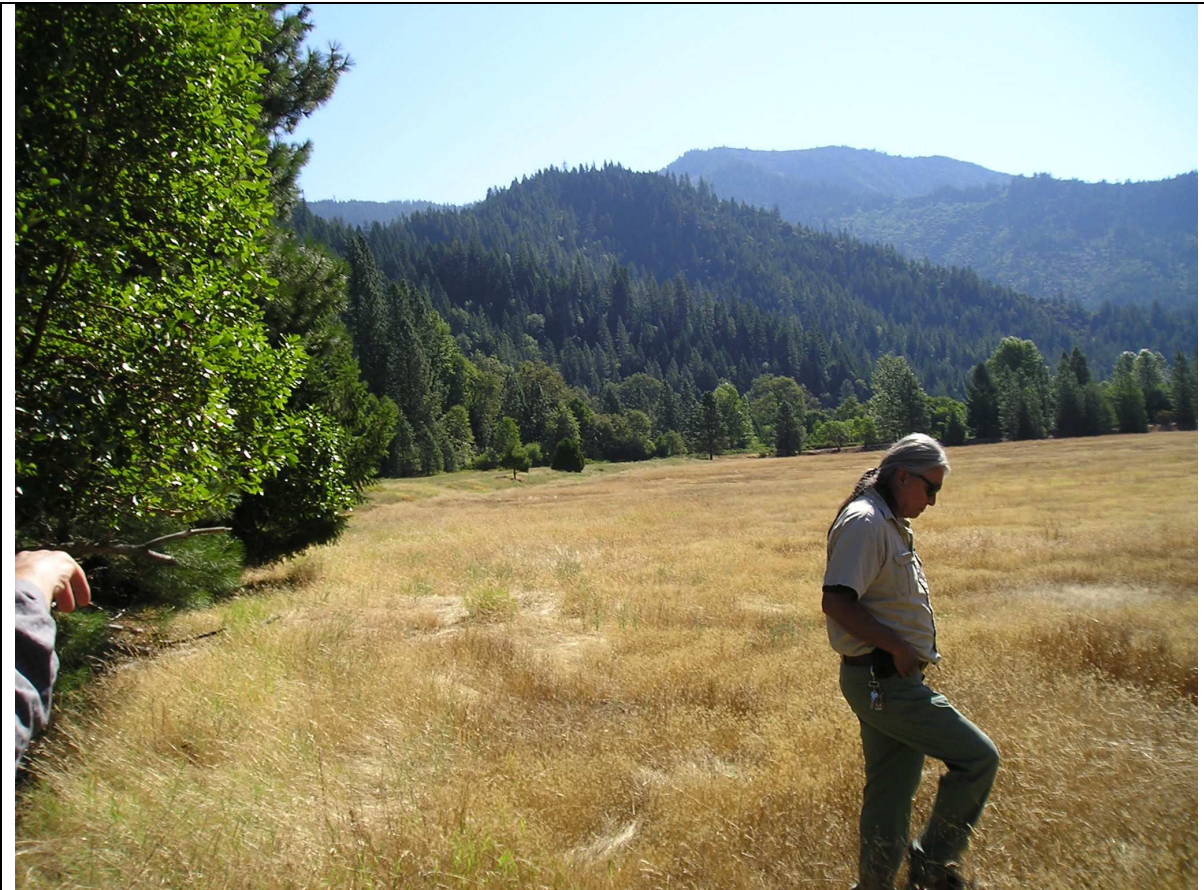
1) Former mill pond location – tailings disposal area – capped (not lined) – note that ditch is located on left – not a drain – rather intended to intercept surface flow prior to contact with tailings disposal area.

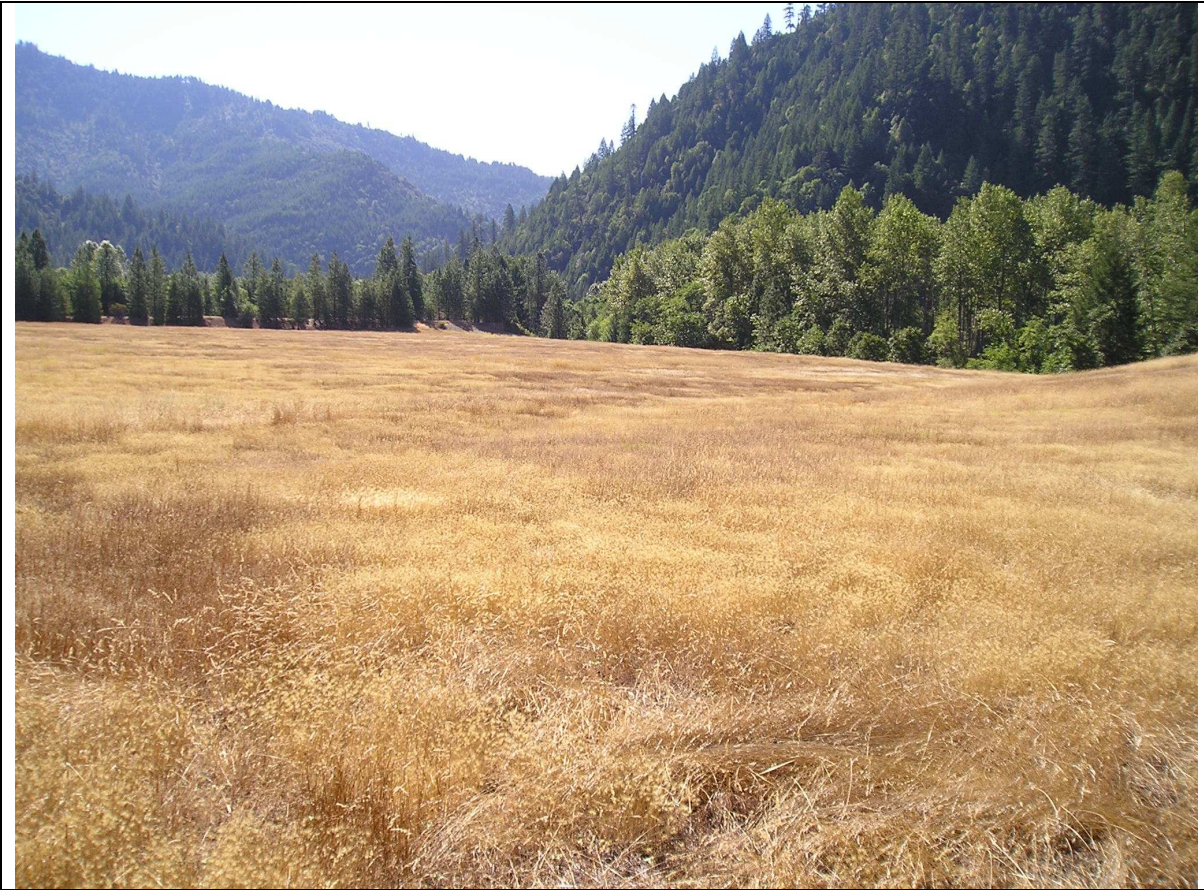
2) View of tailings disposal site – note tree line is border of riparian area adjacent to Indian Creek.

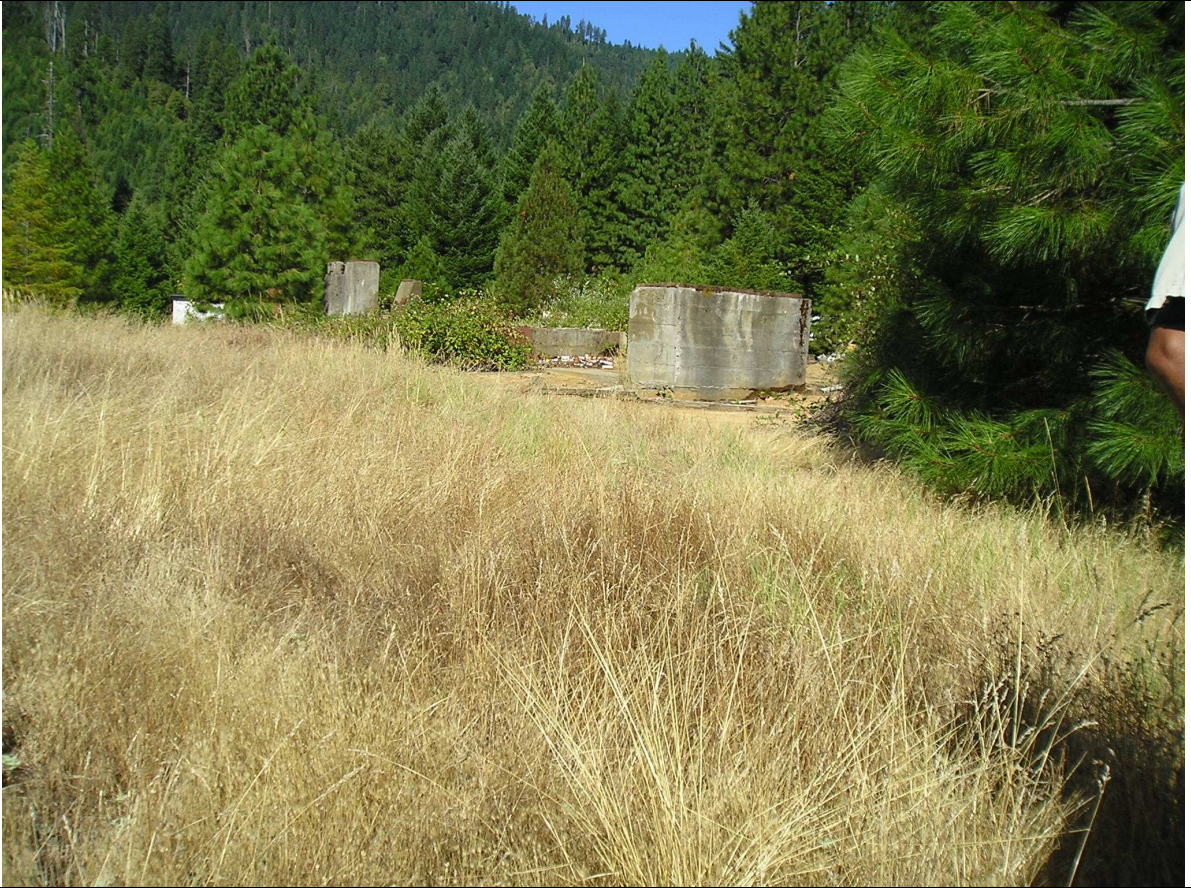
3) Former site of veneer mill – foundation remains in place. Located on edge of tailings disposal area.

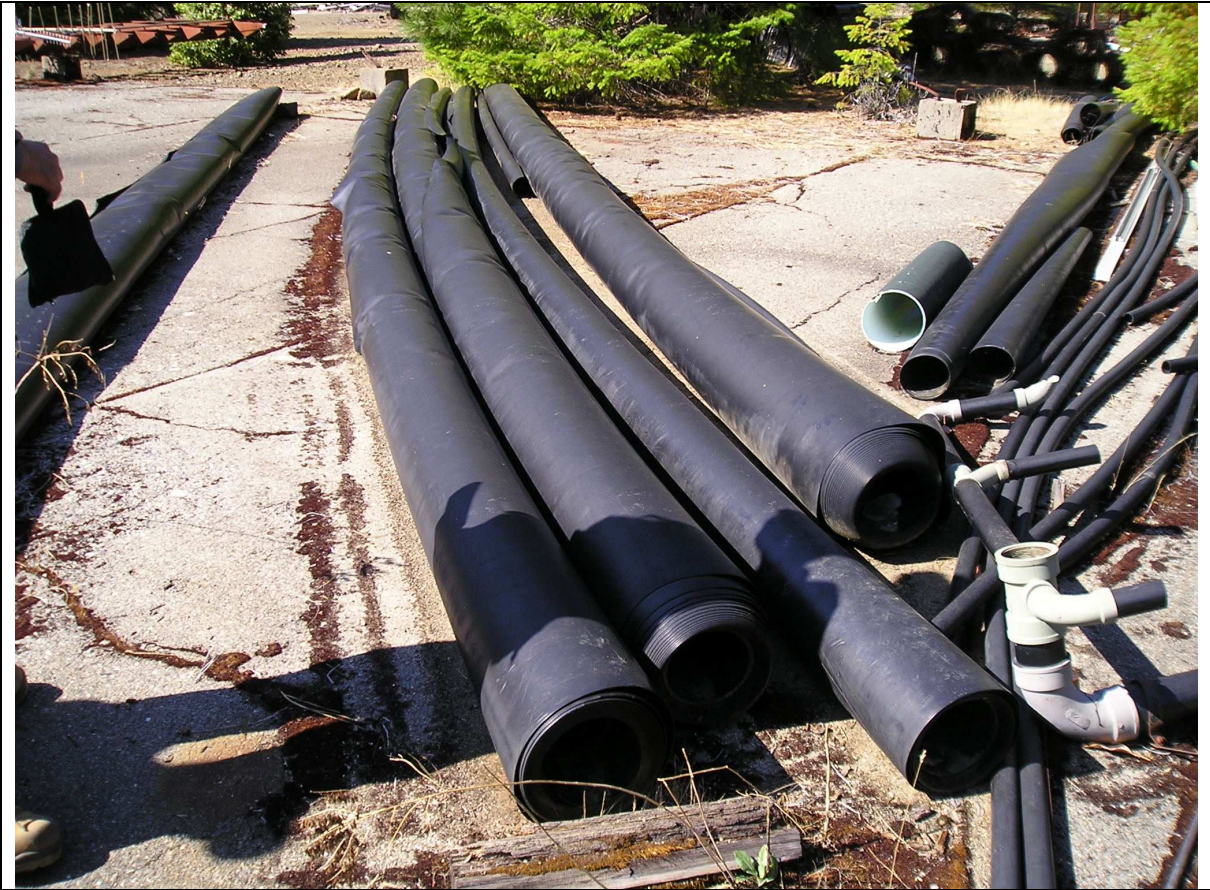
4) Extra cap material stored on foundation of former veneer mill.

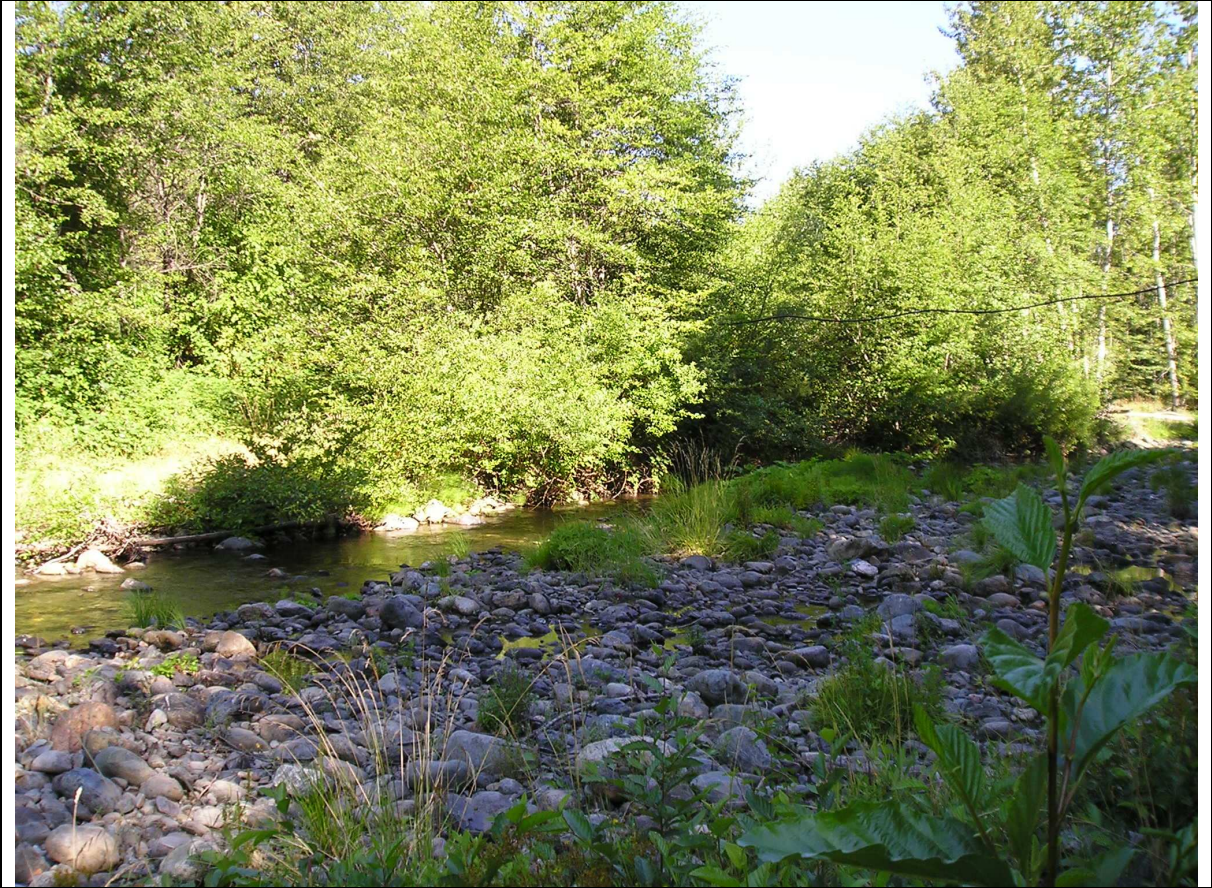
5) Walking upstream – side channel to Indian Creek – flow from Luther and Baker Gulches. Some coho rearing pools located within reach.

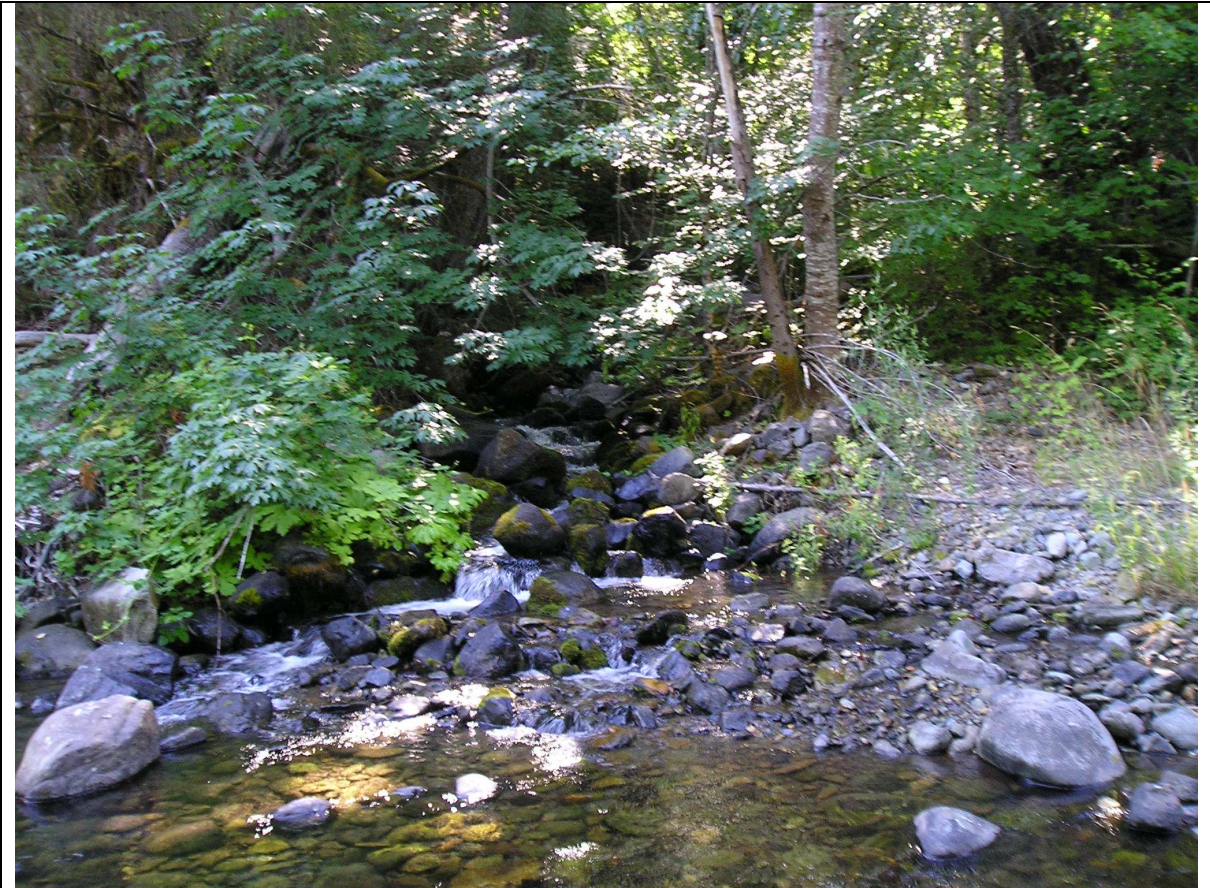
6) Luther Gulch (? Baker Gulch) confluence with side channel. It was reported by those familiar with site that this flow was formerly stained with acid mine drainage.

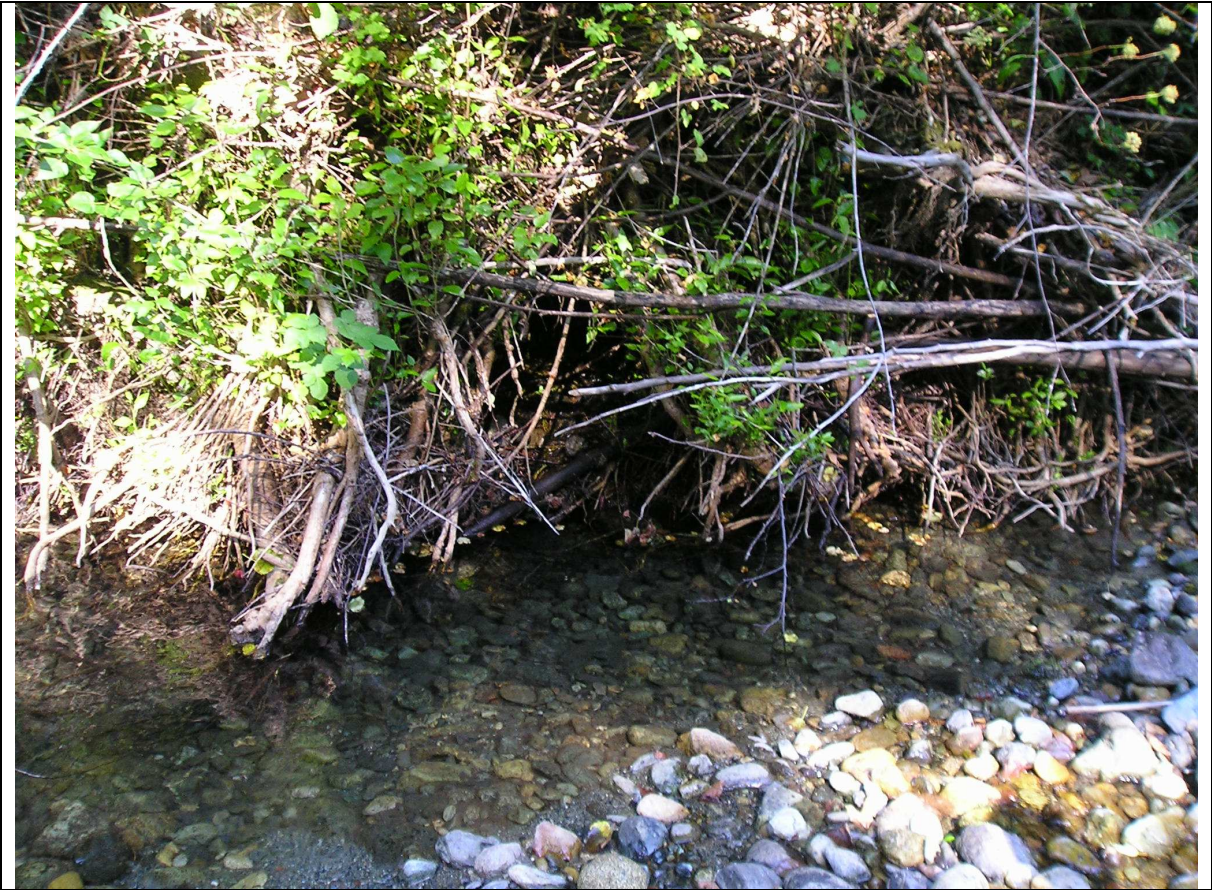
7) Coho spotted in pool beneath root wad. – located on side channel above Luther Gulch.

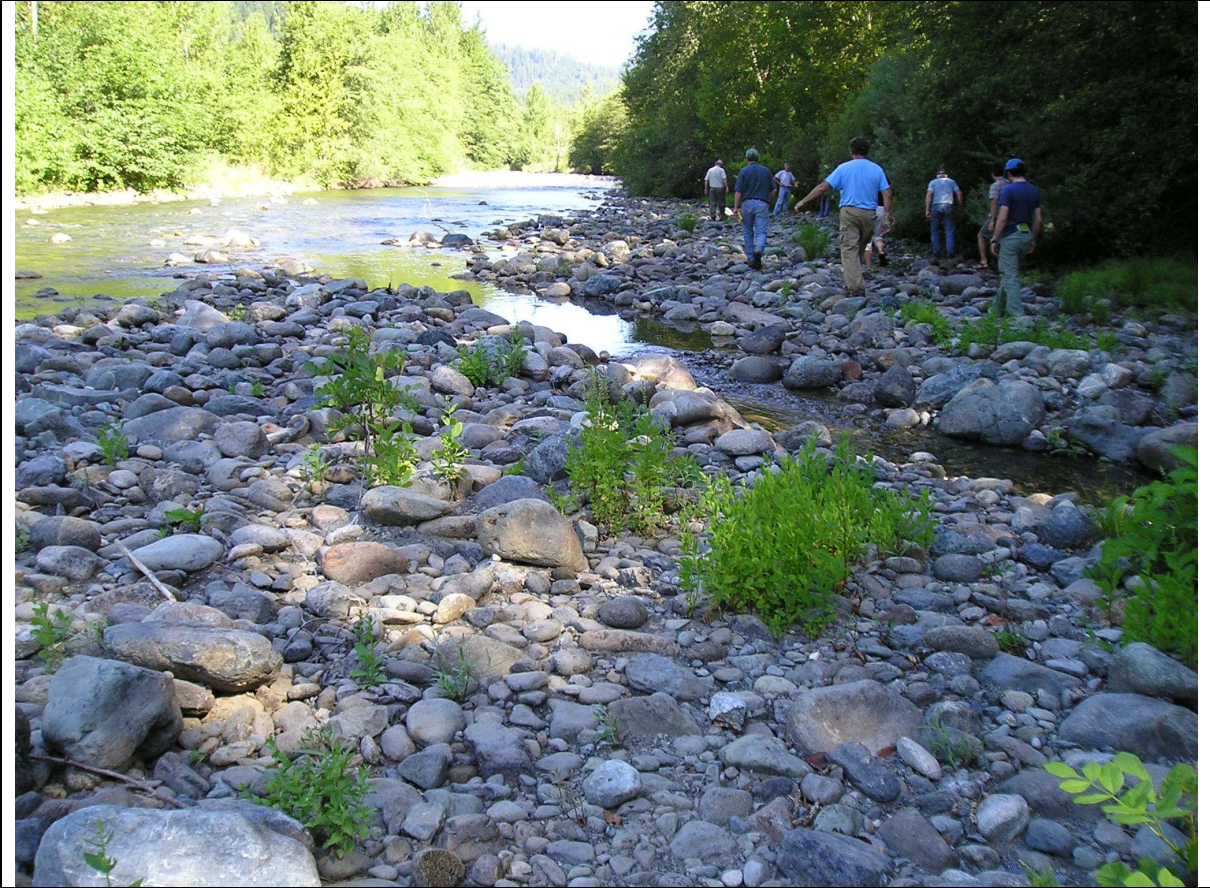
8) Further upstream – side channel splits from Indian Creek,

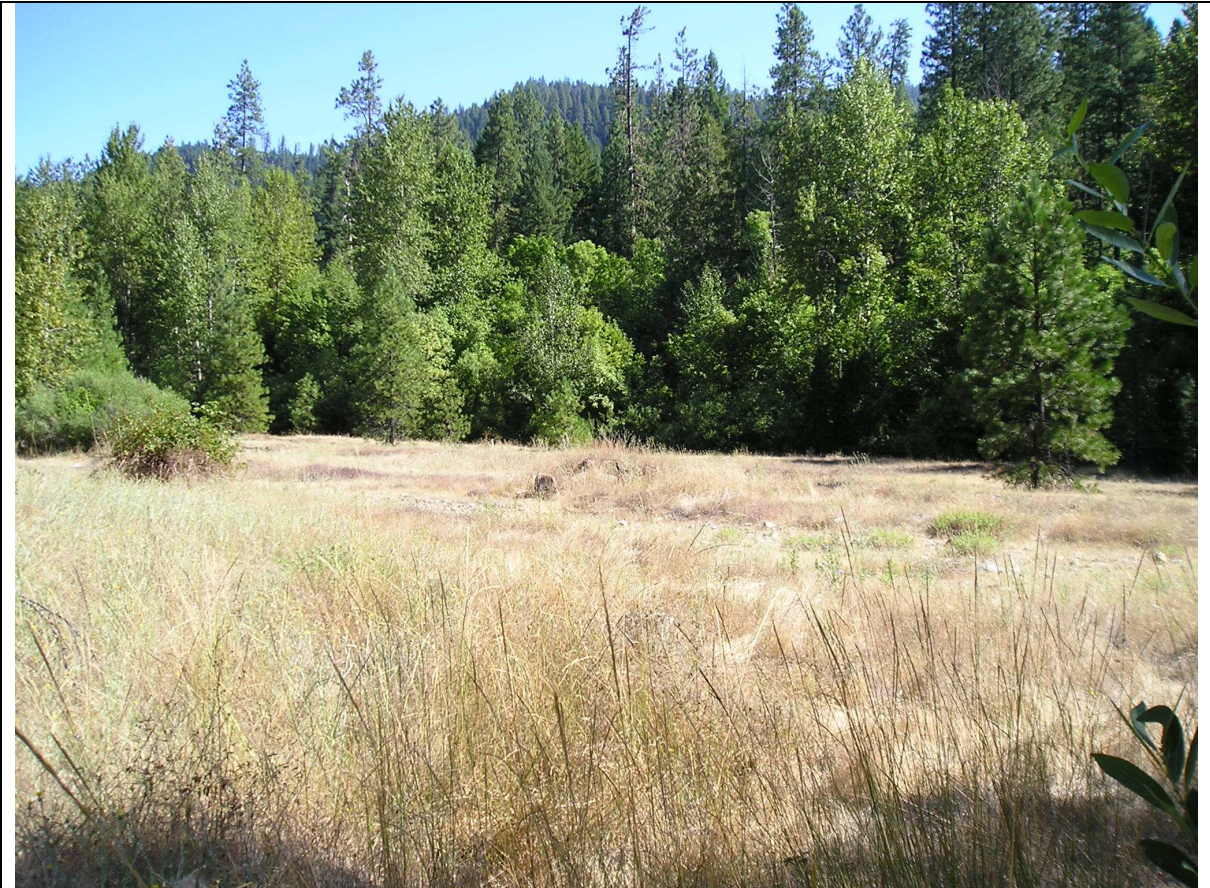
9) Former parking / staging area for tailings material hauling from mine. Parking area not native material but also not tailings.

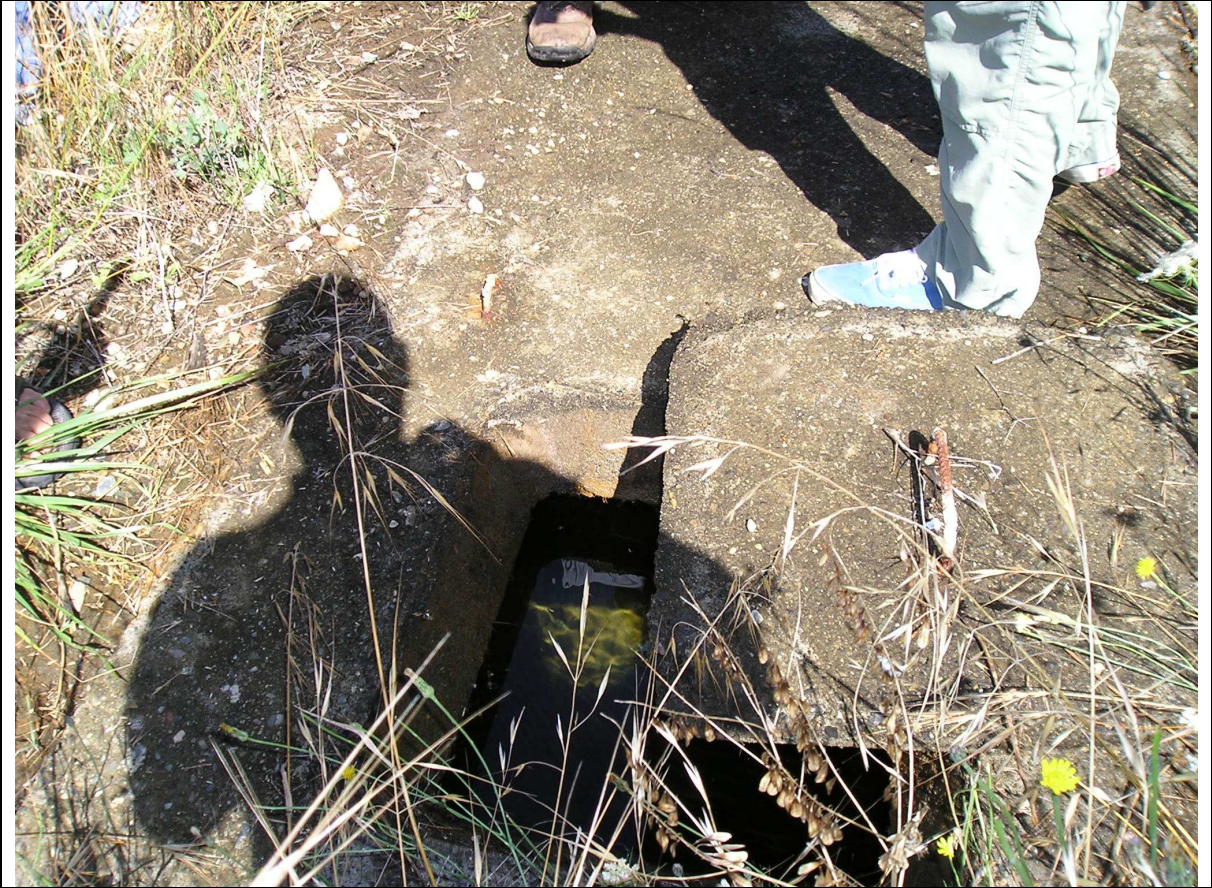
10) Covered box culvert below parking area – approximately six feet depth of clear water in culvert -- colormetric pH ~ 6. Small pools in meadow below box culvert.

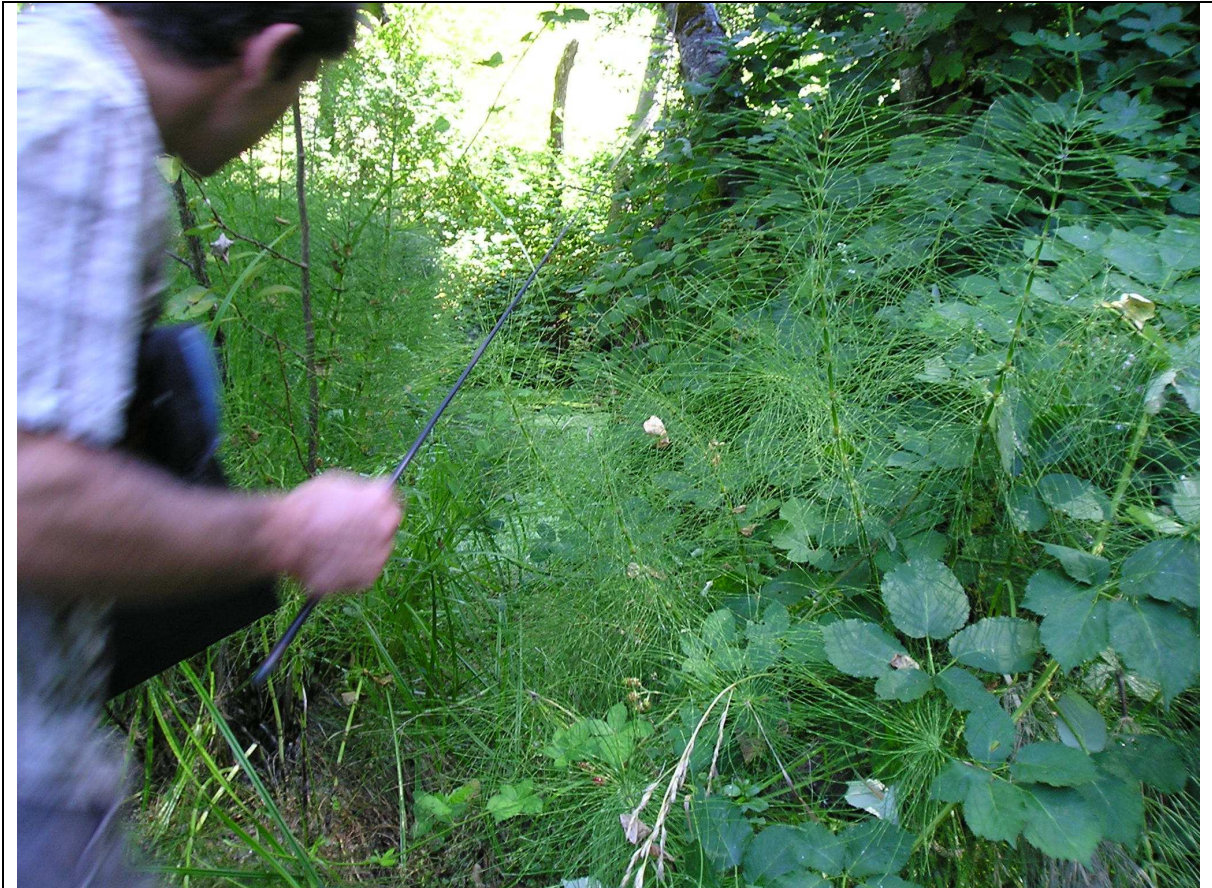
11) Will Harling pointing to side-channel area under consideration as restoration project for coho rearing habitat. Below former parking / staging area on loop back to stream.

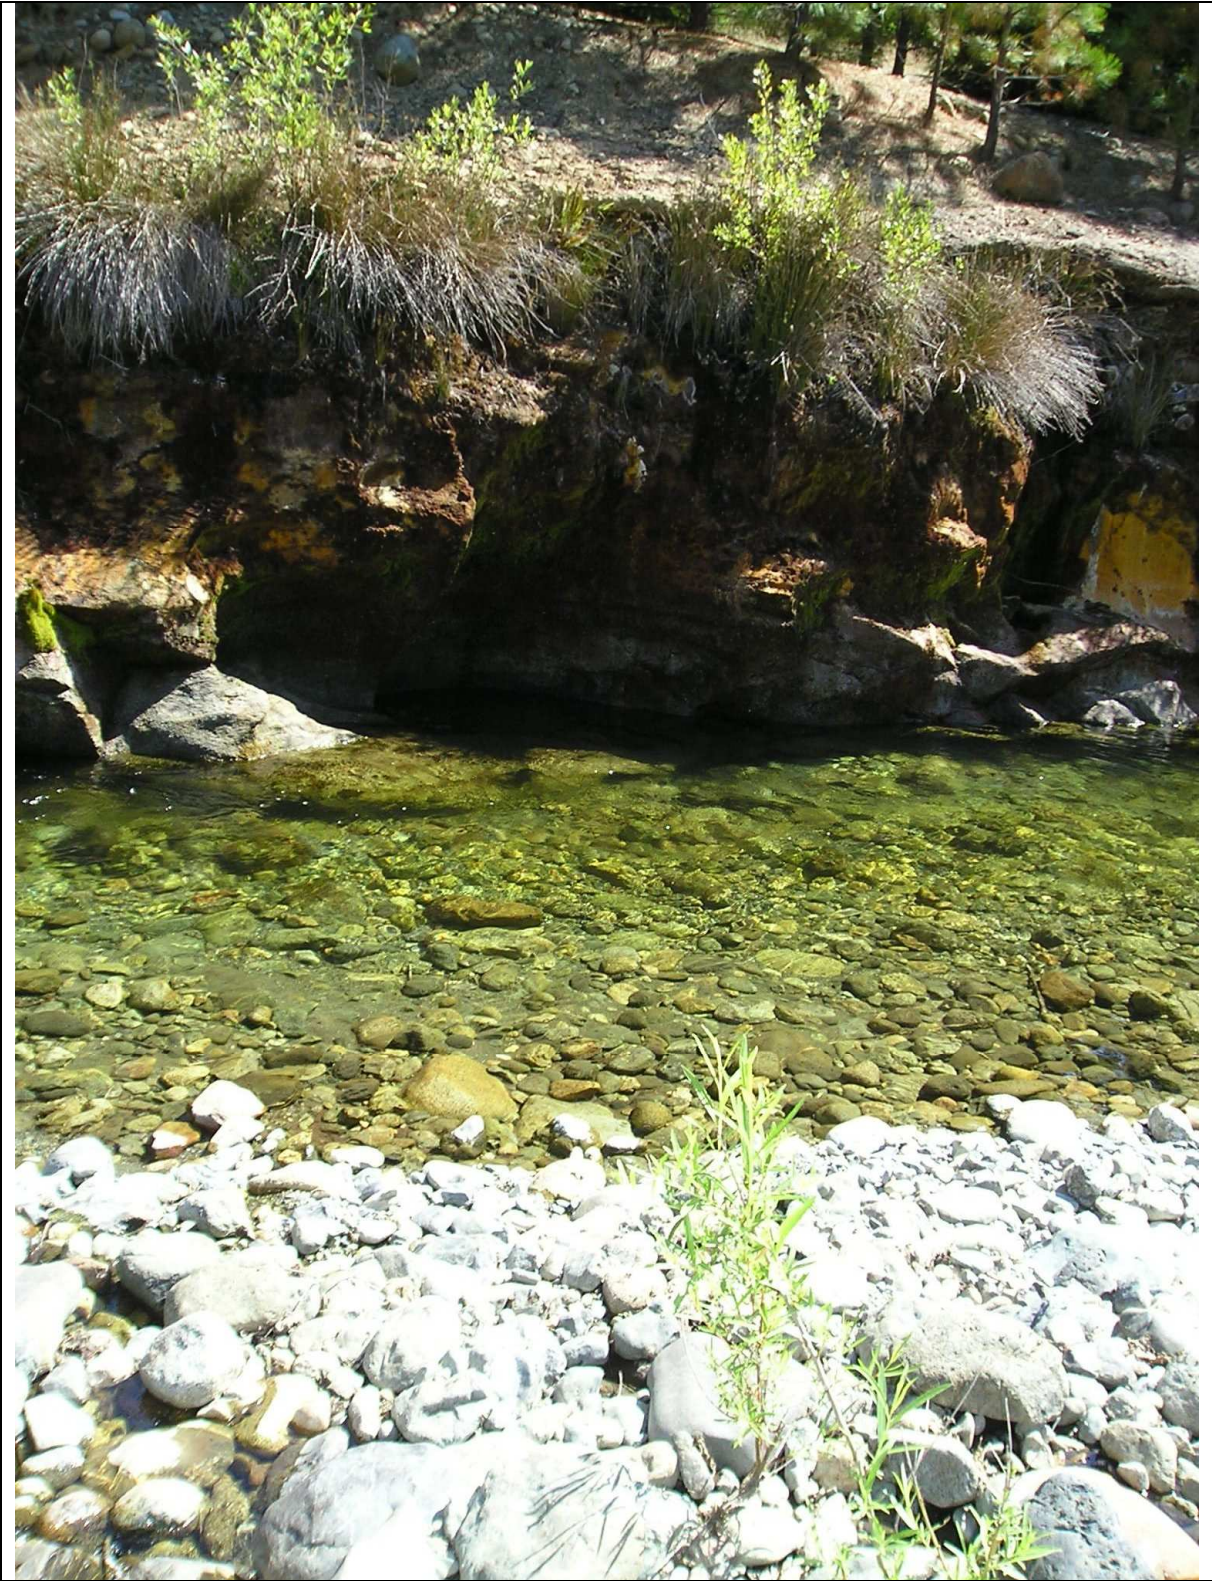
12) Indian Creek just above tailings disposal area showing acid mine drainage staining of streambank. Unknown whether staining is from infiltration or stream flow. Precipitate (sulfide) evident on right hand side of streambank.

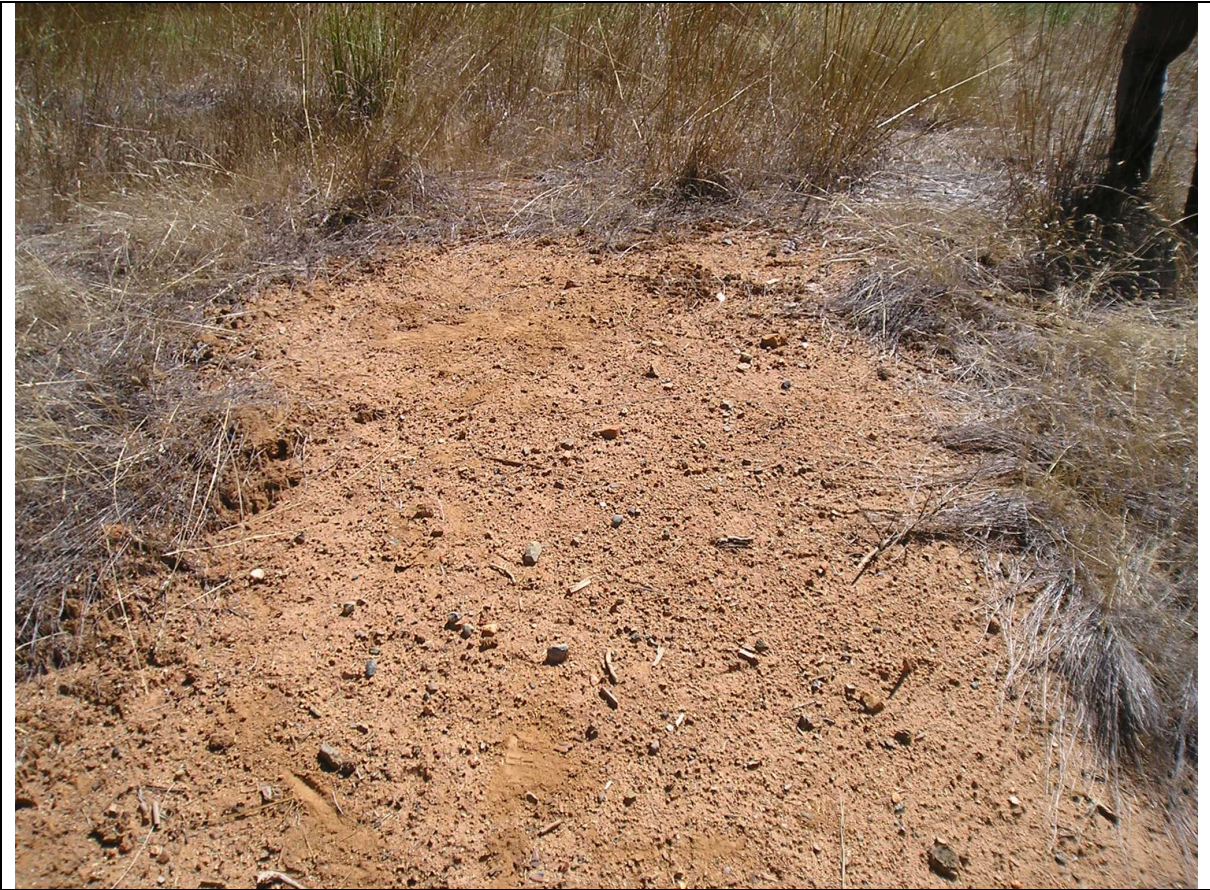
13) Uncapped tailings just above tailings disposal area – adjacent to former veneer mill.

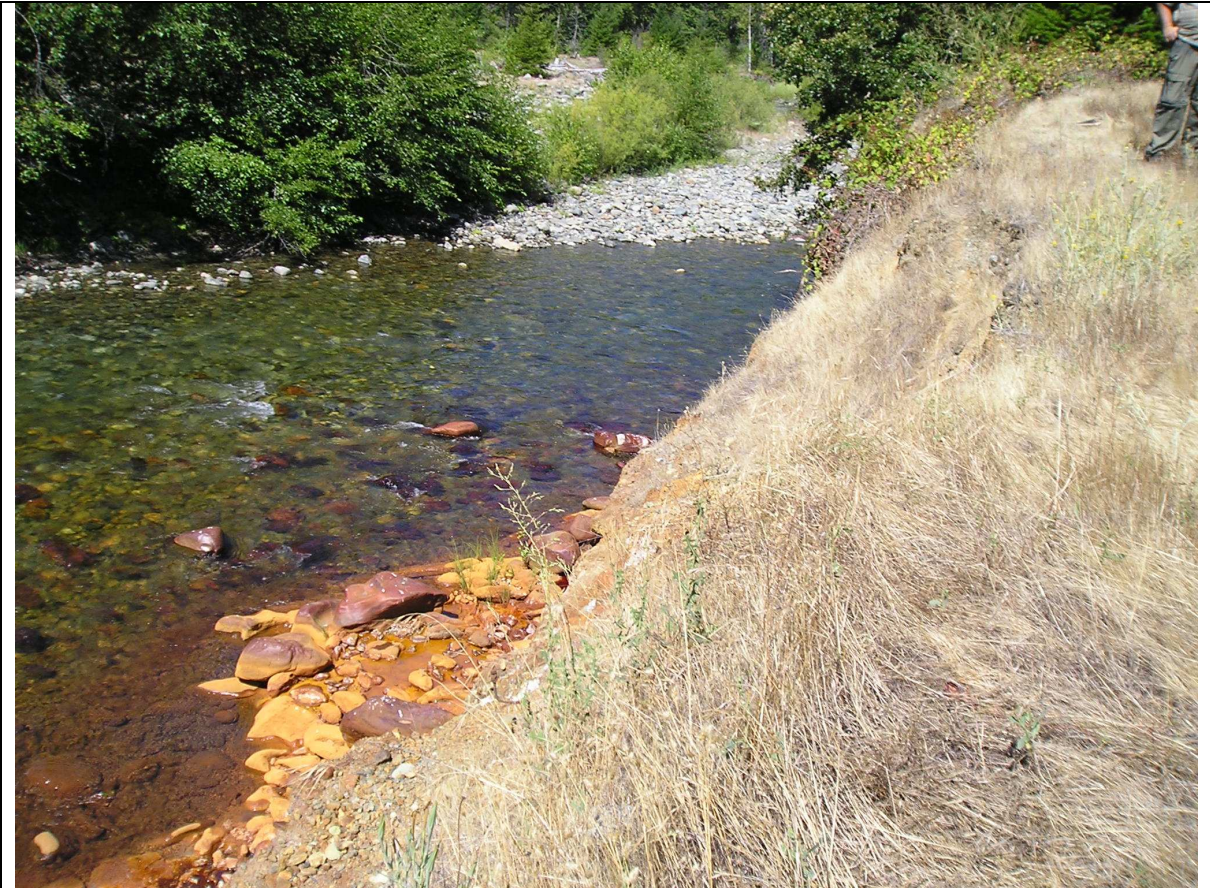
14) Acid mine drainage at toe of embankment of mine tailing disposal area – foundation of veneer mill just to right out of picture.

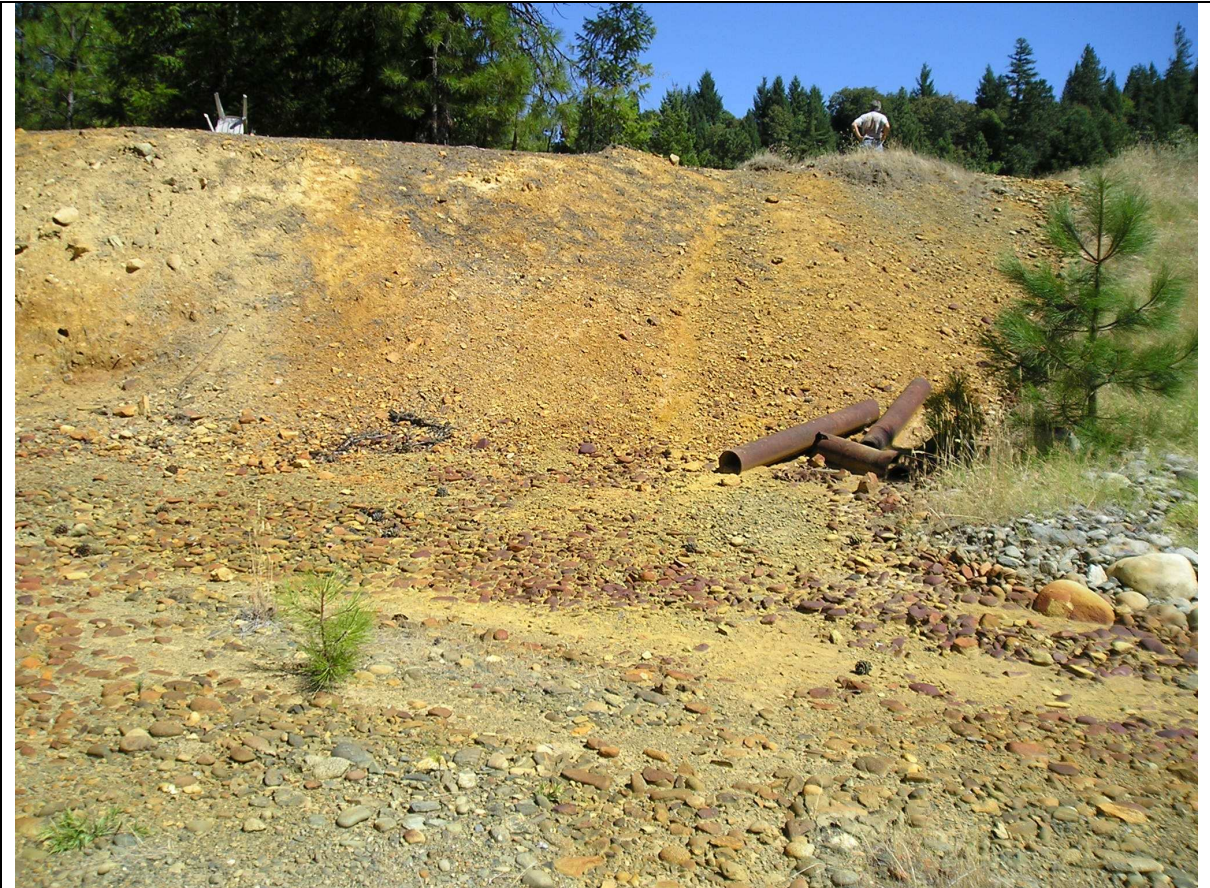
15) Uncapped tailings adjacent to tailings disposal area. Stream directly behind photographer.

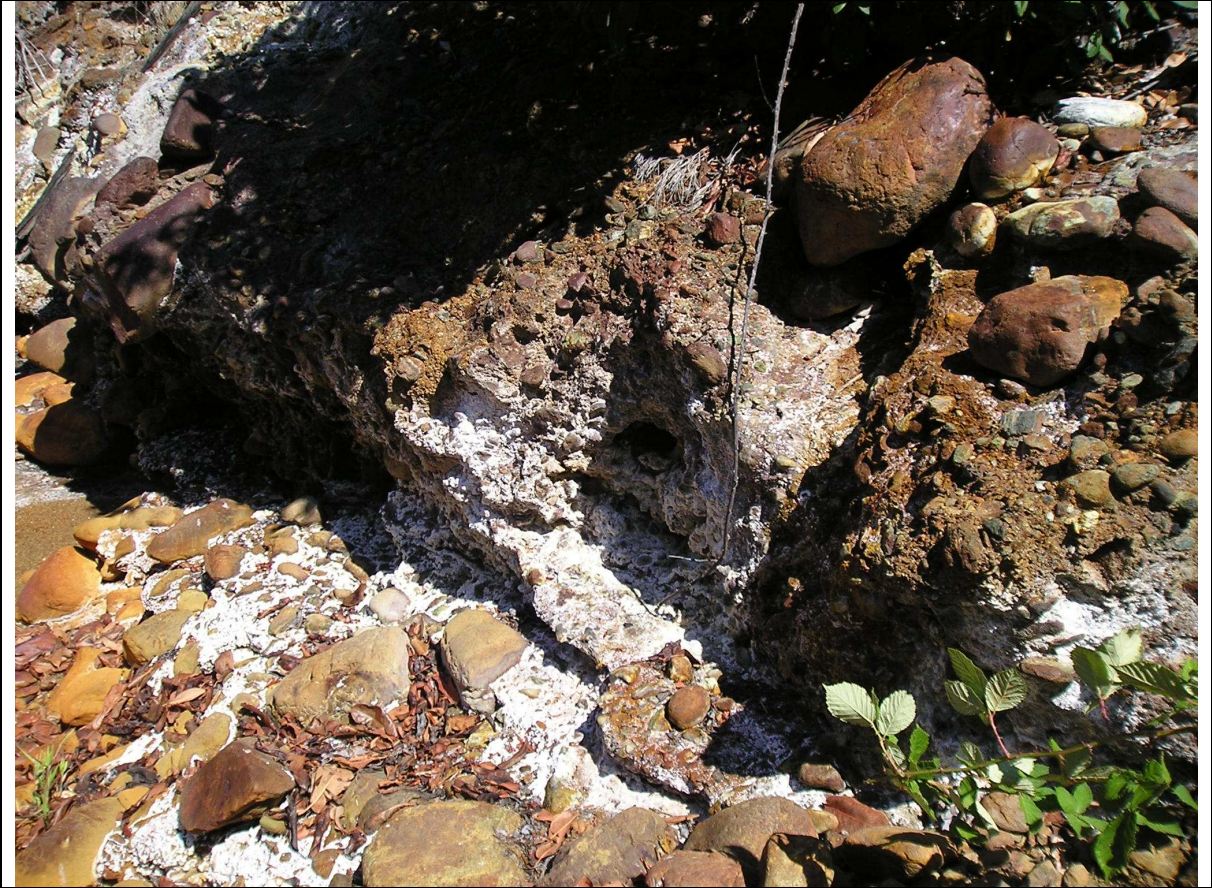
16) Precipitate at toe of streambank below uncapped tailings in previous photographs – this location is at the very upstream end of the tailings disposal area.

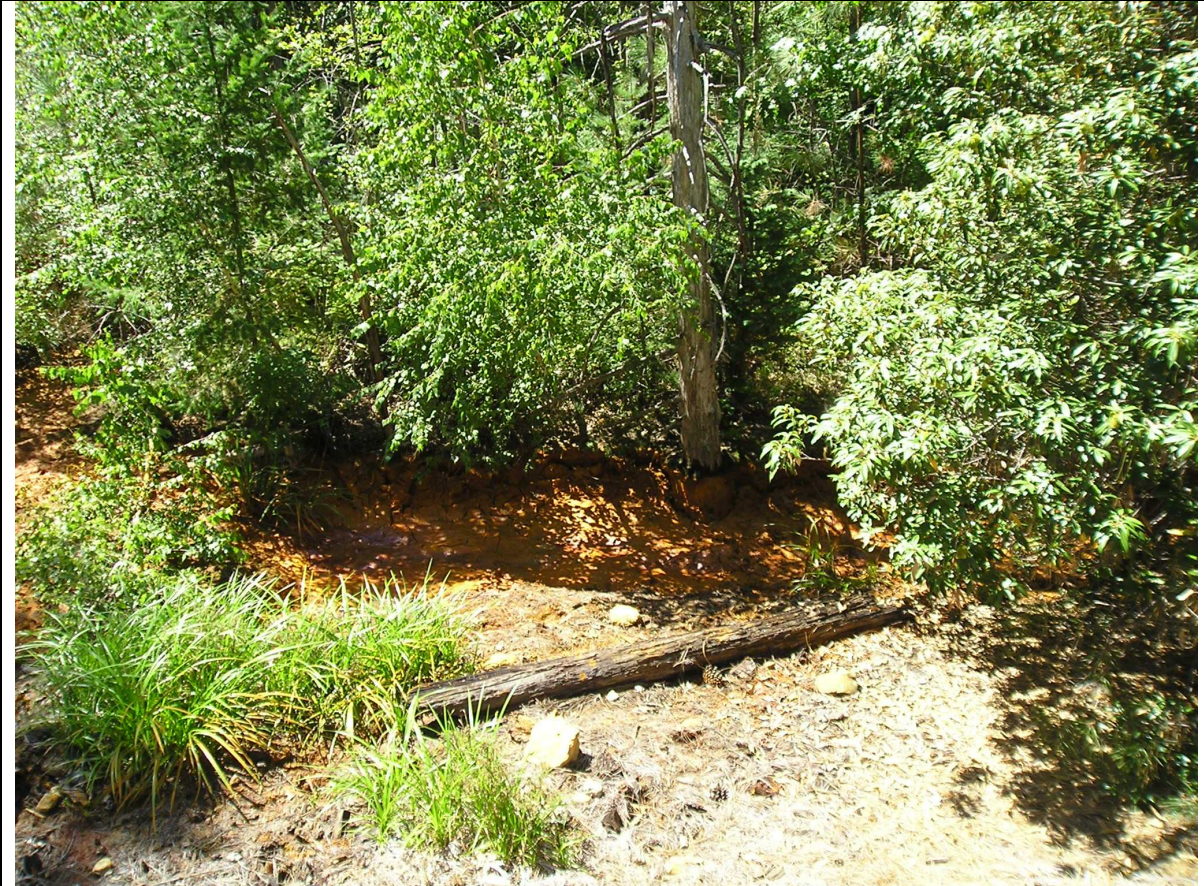
17) Downstream end tailings disposal area – acid mine drainage seep – unclear whether there is an upstream source or leaking from capped area.
